## MODEL 124

P91.10-0544-01

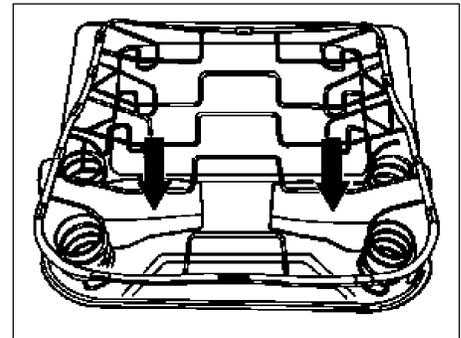
Damage Code	Cause	Remedy	
No Code	<ul style="list-style-type: none"> <li>Insufficient side support of seat cushion frame.</li> <li>With extreme weight on the front seat, the seat cushion cover can be pinched at the front seat tilt adjustment mechanism.</li> </ul>	<p>1 Install two foam block to the seat cushion padding on the left and right side between the two front springs. Part No: 124 910 16 75</p> <p>
