30–0400 Retrofitting Accelerator Control Shaft and Bearing Bracket (SA only)

Model 126 Engine 603.96 (SA) effective Model Year 1986

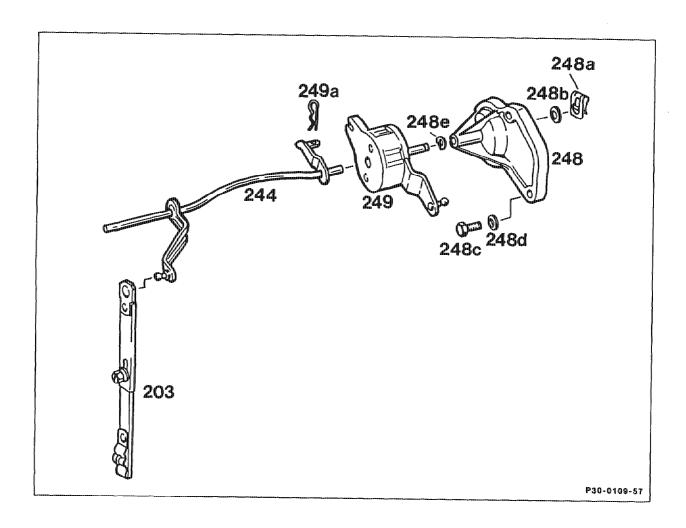
A modified accelerator control shaft with bearing bracket can be retrofitted to eliminate accelerator pedal vibration.

The bearing points and ball sockets of the accelerator control should be greased with DB anti-corrosion grease 000 989 87 57 10 with the exception of the link between the accelerator control shaft (244) and lever (249).

With the engine switched off, depress accelerator pedal as far as stop on the kickdown switch from the interior of the car. The control lever of the injection pump must move against the full throttle stop (arrow). Adjust profile rod, if necessary. It is essential to ensure that the accelerator control moves freely.
