Operation No. of operation texts and work units or standard texts and flat rates: 15-2093

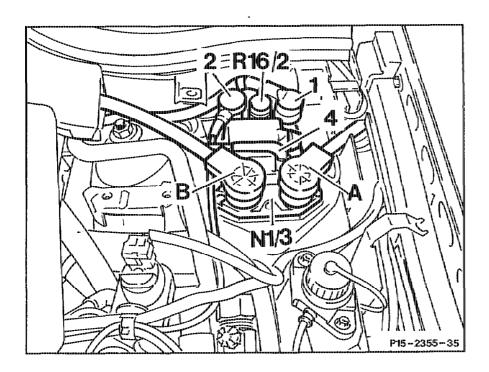
detach, fit on.
unplug, plug in.
unscrew, screw on (3 nuts). Pay attention to washers.
remove from stay bolt, fit on.

Heat conducting paste has been applied to the rear of the control unit and covered with heatconducting protective foil for improved heat dissipation. The protective foil must not be removed.
